**Title:**           **Analysis of International Space Station Vehicle Materials on MISSE 6**

*National Space & Missile Materials Symposium*

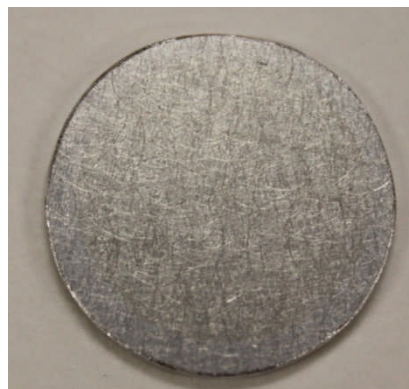
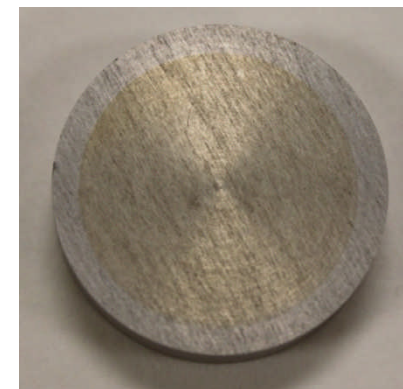
- **Four batches of sulfuric acid anodize processed at MSFC.**
  - **Fan blades, sample trays, small frames, samples**
- **Hot deionized water seal specifically called out.**
- **Three batches of 6061-T6 did not darken.**
- **Fourth batch did darken. Post-flight analysis did not detect nickel, so no inadvertent use of nickel acetate. This batch was processed with samples and small frames made of AL 2195, an aluminum-lithium alloy**
- **Other problems observed in anodizing aluminum-lithium alloys**
  - **Previous attempts to black dye anodize AL 2195 have failed**
  - **Black dye particles can be wiped off after processing**

- **Should not use nickel acetate in anodize seal**

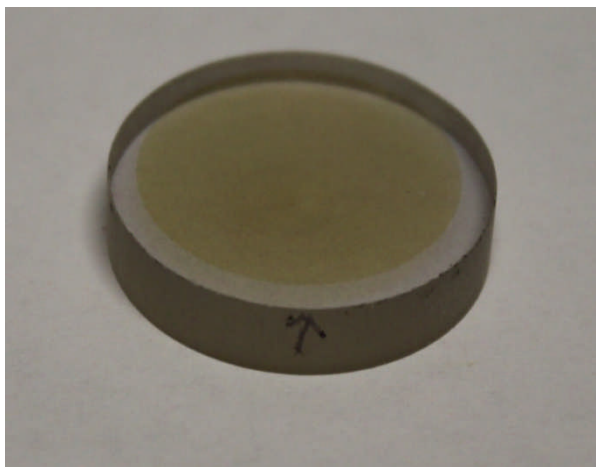
- Used as scratch panes or debris panes protecting ISS windows
- Protective coating applied for atomic oxygen resistance
- Mass loss was 1.34 mg for ram sample, 0.86 mg for wake

With protective coating.  
Some UV darkening.

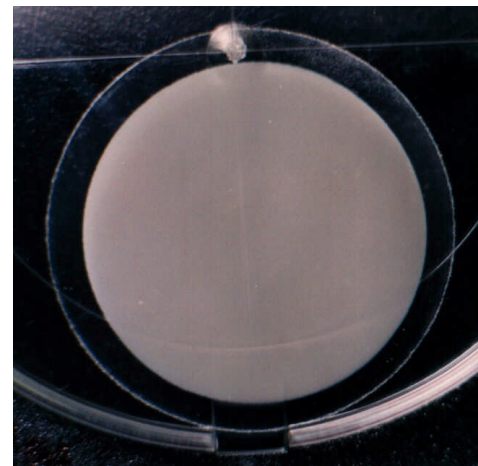
Polycarbonate from previous  
flight experiment, no coating,  
heavily eroded by atomic oxygen

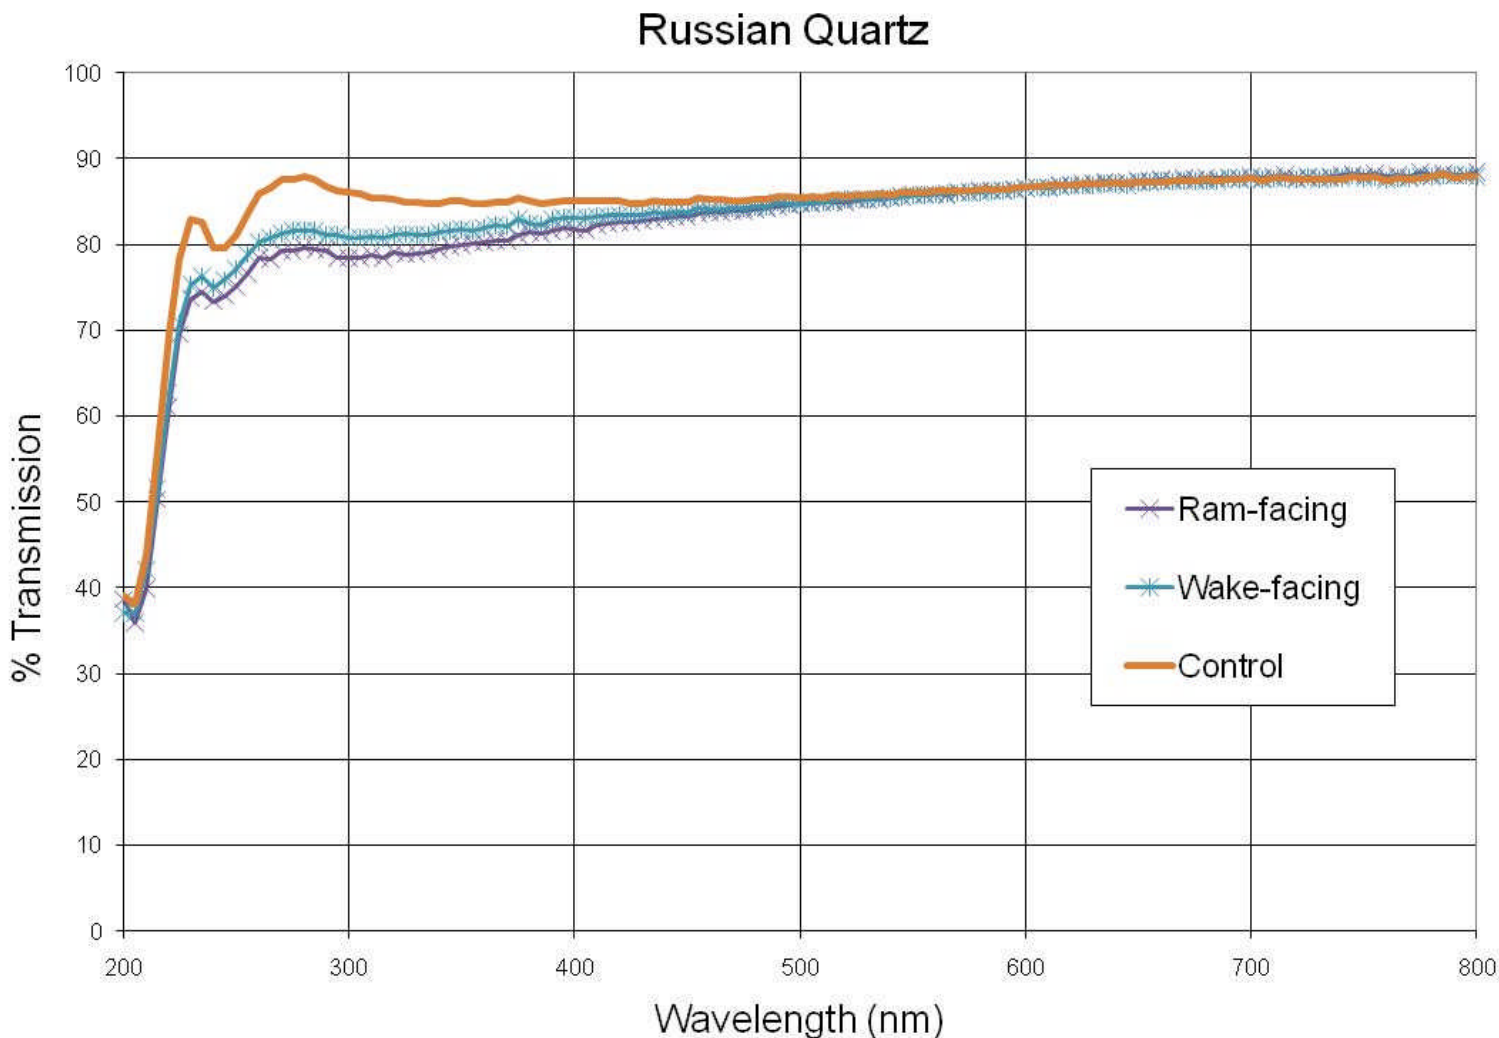
- **Used on Zvezda Service Module**
- **Earth observation**
- **Slight decrease in transmission in UV wavelengths**
- **No visible change in appearance**
